Safety Inspection Report

Annual Inspection

Broad Chalke Playground

21 October 2025

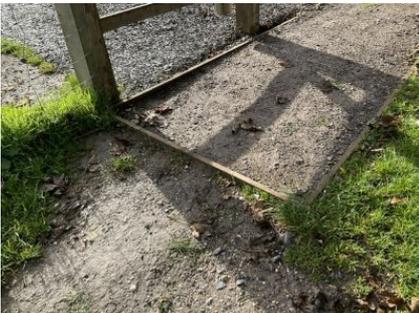
Trip points on the surface.

Remove trip points.

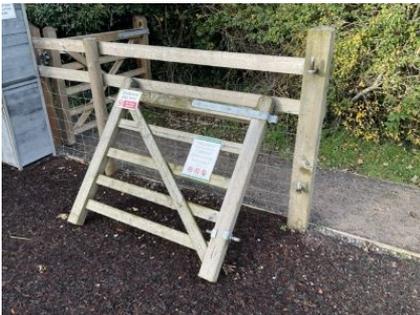
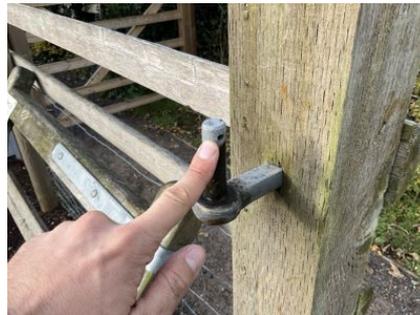
Item is not secure.

Pin/bolt required to prevent the gate from being lifted up.

Secure.

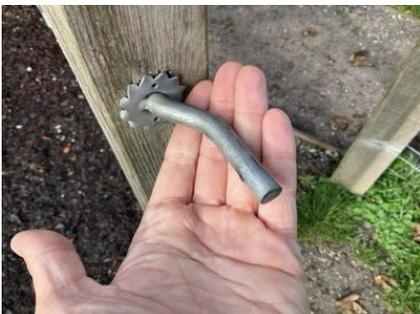
Hard or sharp projections.

Fit a cap.

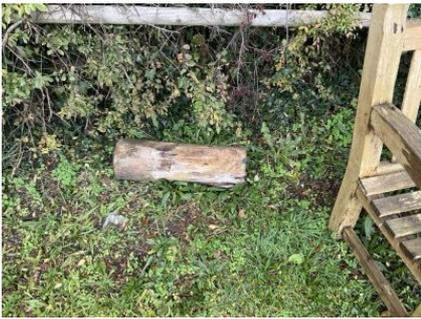
Litter on site.

Clean up.

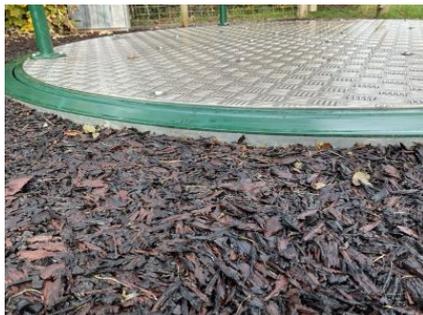
Surface is uneven.

There appears to be displacement/compaction. Monitor.

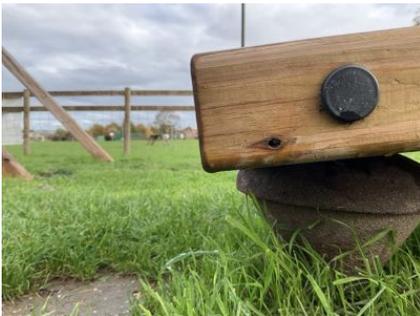
Changes in shape of the main profile are less than the minimum permitted 20 mm radius.

No reasonably practicable action is identified.

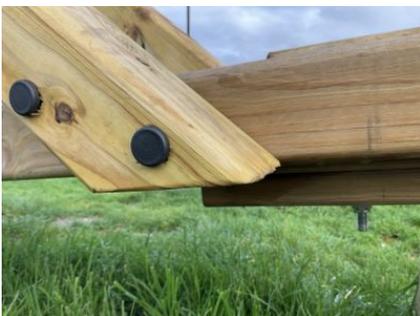
Edges not radiused or chamfered.

Round over.

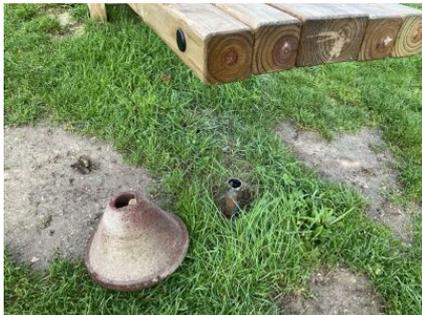
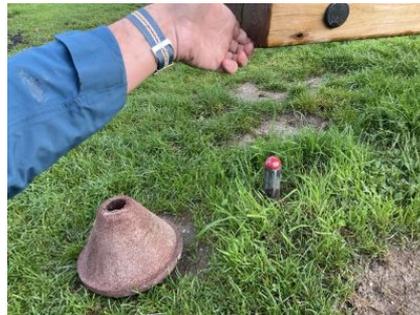
Item is not secure.

Secure.

Refer to manufacturer.

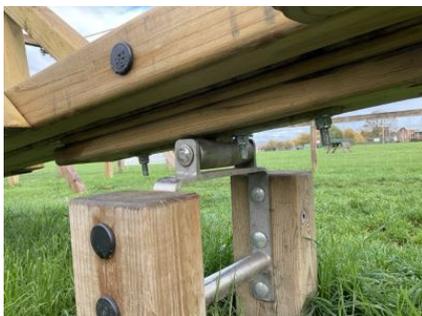
Projecting bolt thread.

Cut off and file down to remove sharp edges or use the correct length of bolt.

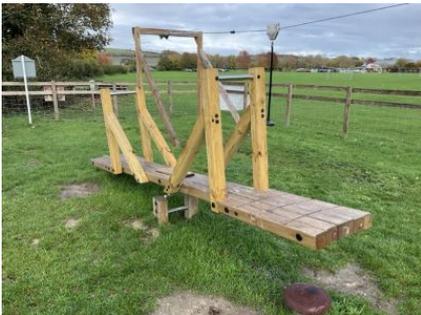
Excessive lateral flex in the structure.

Refer to the manufacturer for comment.

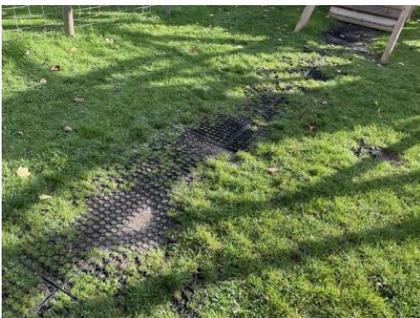
Worn ground areas.

Worn, uneven grass matting. The surface may not provide adequate impact attenuation.

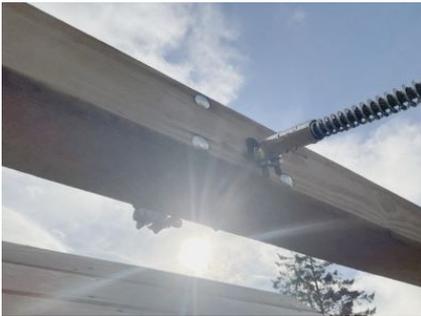
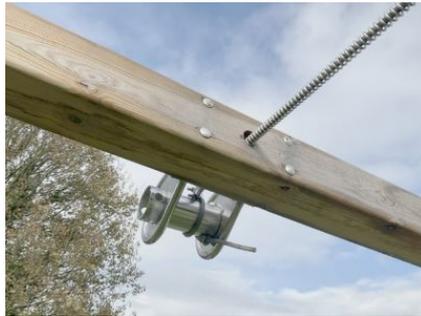
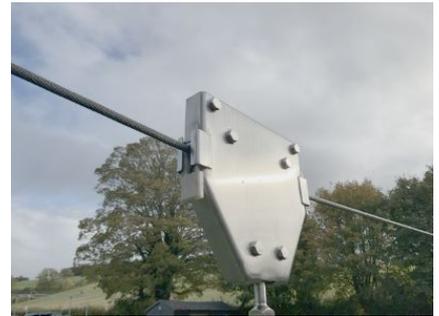
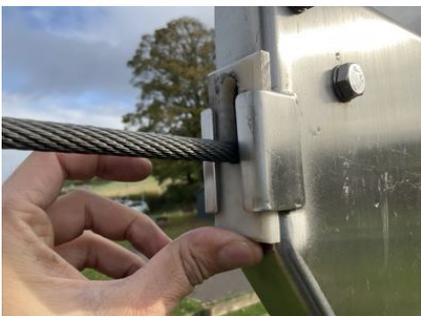
Cables have been known to fail under load due to wear and corrosion. This is generally where the cable enters into a tube, top bar, sleeve or similar, where the wire is in contact and wears and frays over time, but can happen anywhere on the cable. It is important to inspect any hidden parts at least annually. Damaged cables require replacement. This cannot be determined during an annual inspection, and is excluded from our inspection. This can lead to a high risk if no action is taken. Refer to the manufacturer's instructions to ensure the correct check is carried out.

Finger guard/cable guide heavily worn. Replace. Cable causing significant damage to the starting section main support. Refer to manufacturer.

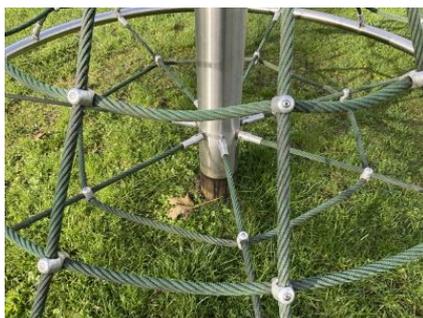
There is wear in the bearings.

Monitor and replace when necessary.

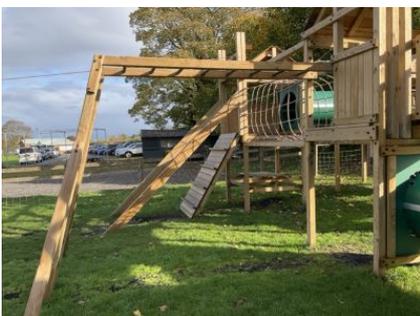
Overhead ladders and rings provide significant play value and benefits to children, and with it the risk of falling. Ensuring the surface remains in good condition will help to keep the correct balance between benefits and risk.

The protective surface under all bars and rings must be kept in good condition.

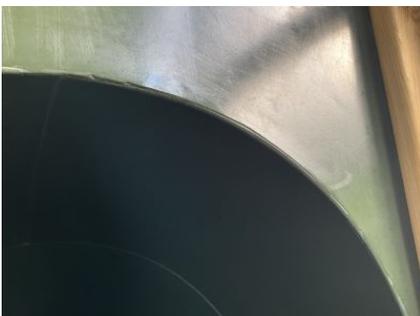
Item is cracked.

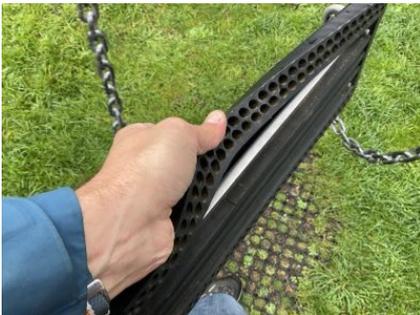
The swing seat has been damaged, but does not require immediate replacement.

Replace. Refer to manufacturer for comment.
