Safety Inspection Report

Annual Inspection

Broad Chalke Playground

21 October 2025

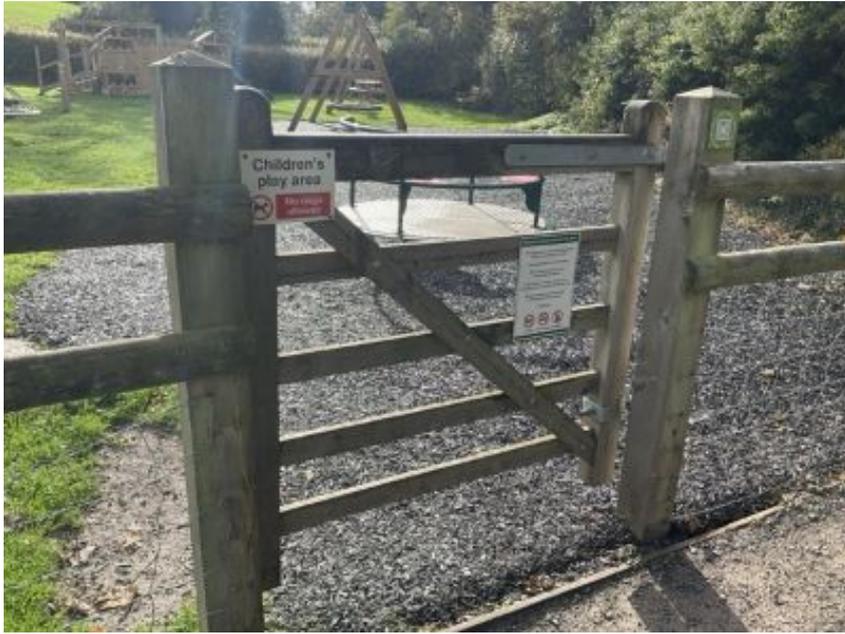
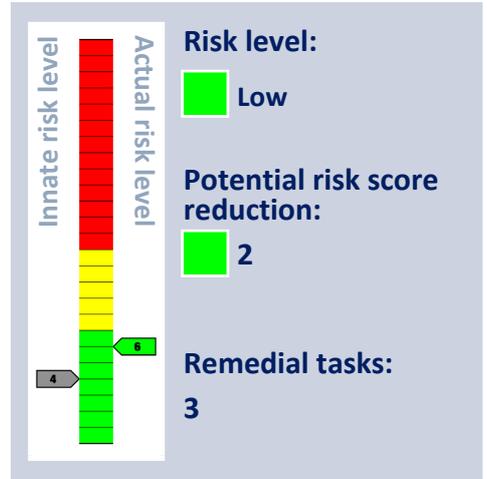
Gates - Pedestrian

Description	Tasks	Risk score
Trip points on the surface.	Remove trip points.

6
Item is not secure.	Secure.

6
Hard or sharp projections.	Read the notes for further action.

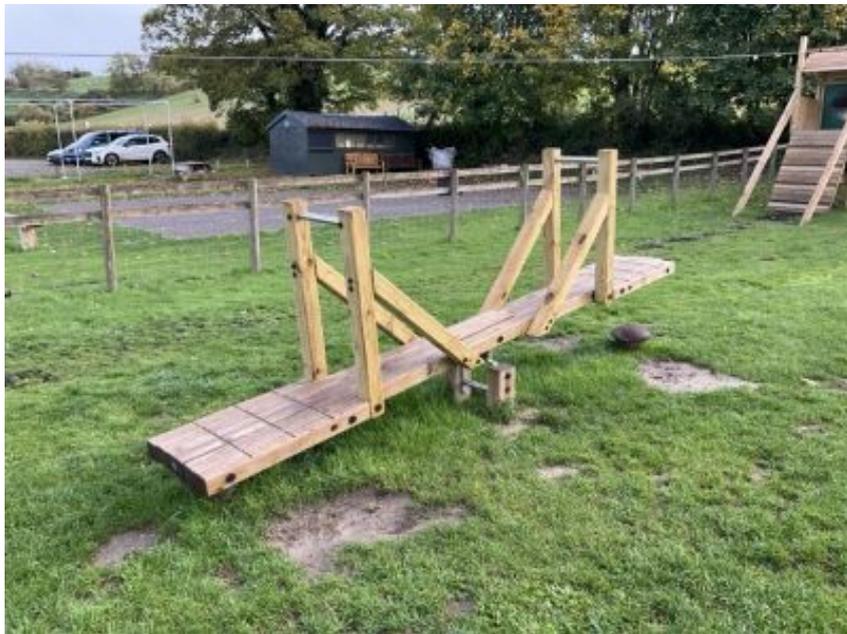
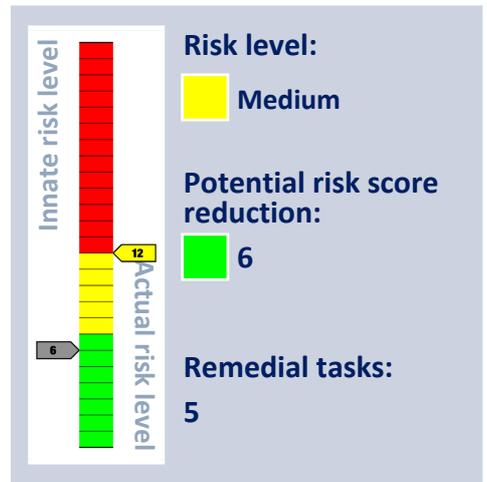
Rocker - Seesaw - Standing

1. Item is not secure.
2. Projecting bolt thread.
3. Additional comments are noted below.

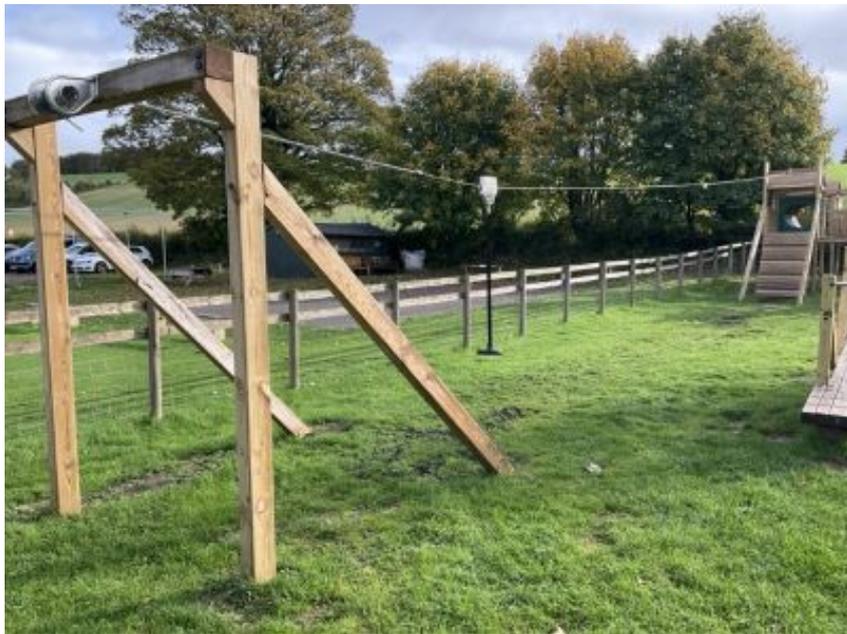
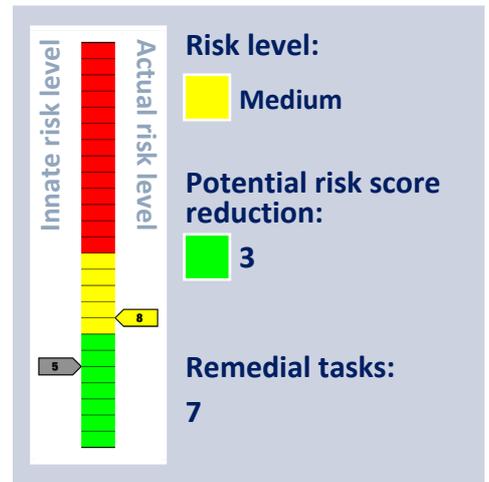
Cableway - Seated

1. Additional comments are noted below.
2. Worn ground areas.
3. Cables have been known to fail under load due to wear and corrosion. This is generally where the cable enters into a tube, top bar, sleeve or similar, where the wire is in contact and wears and frays over time, but can happen anywhere on the cable. It is important to inspect any hidden parts at least annually. Damaged cables require replacement. This cannot be determined during an annual inspection, and is excluded from our inspection. This can lead to a high risk if no action is taken. Refer to the manufacturer's instructions to ensure the correct check is carried out.
4. Chain covers prevent a thorough inspection of all chain links.

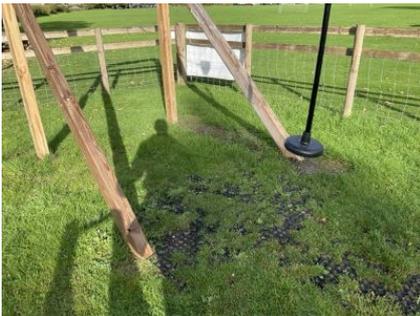
Additional comments are noted below.

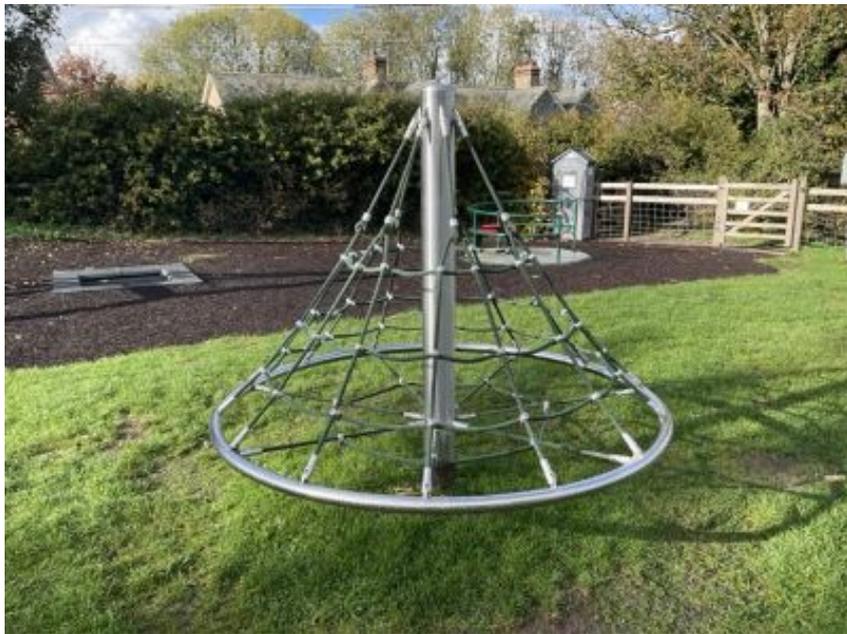
Climber - Rota Web

There is wear in the bearings.

Monitor and replace when necessary.

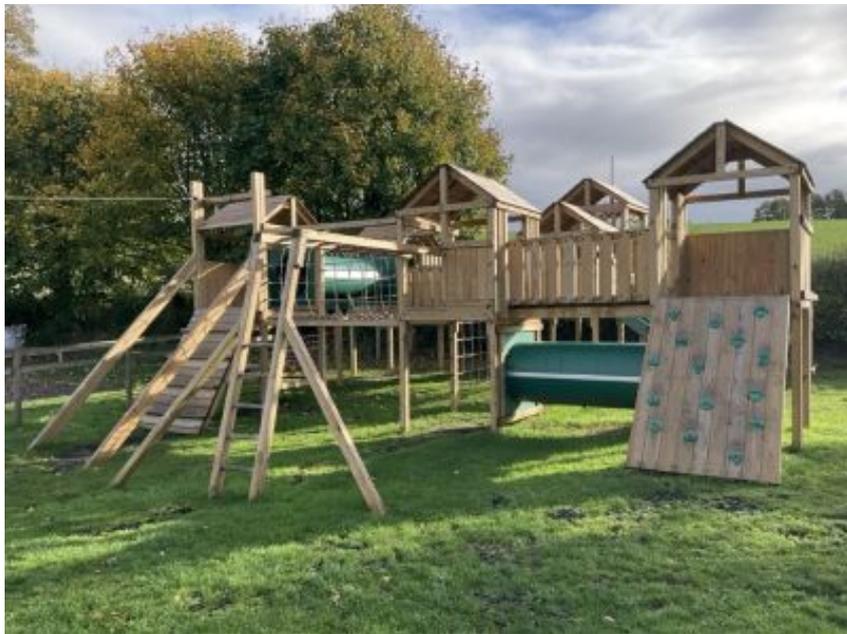
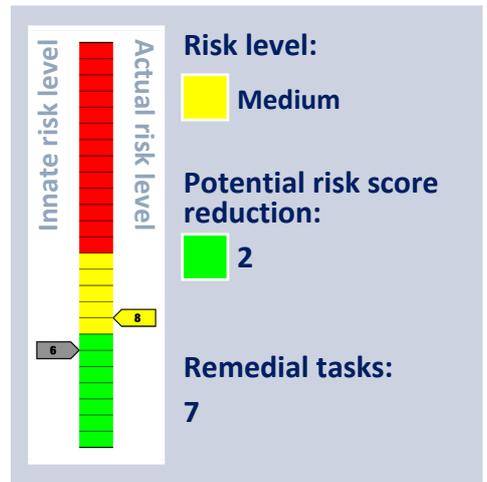
Multiplay - Junior

1. Overhead ladders and rings provide significant play value and benefits to children, and with it the risk of falling. Ensuring the surface remains in good condition will help to keep the correct balance between benefits and risk.
2. Projecting bolt thread.
3. Item is cracked.

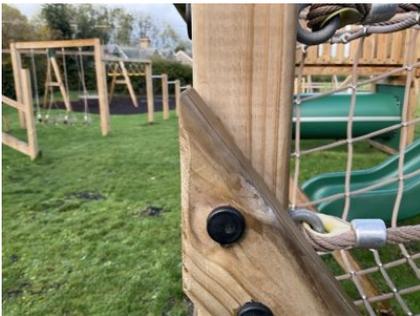
Overhead ladders and rings provide significant play value and benefits to children, and with it the risk of falling. Ensuring the surface remains in good condition will help to keep the correct balance between benefits and risk.

The protective surface under all bars and rings must be kept in good condition.

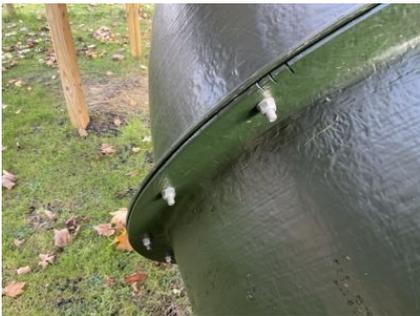
Item is cracked.

Item is cracked.	Read the notes for further action.

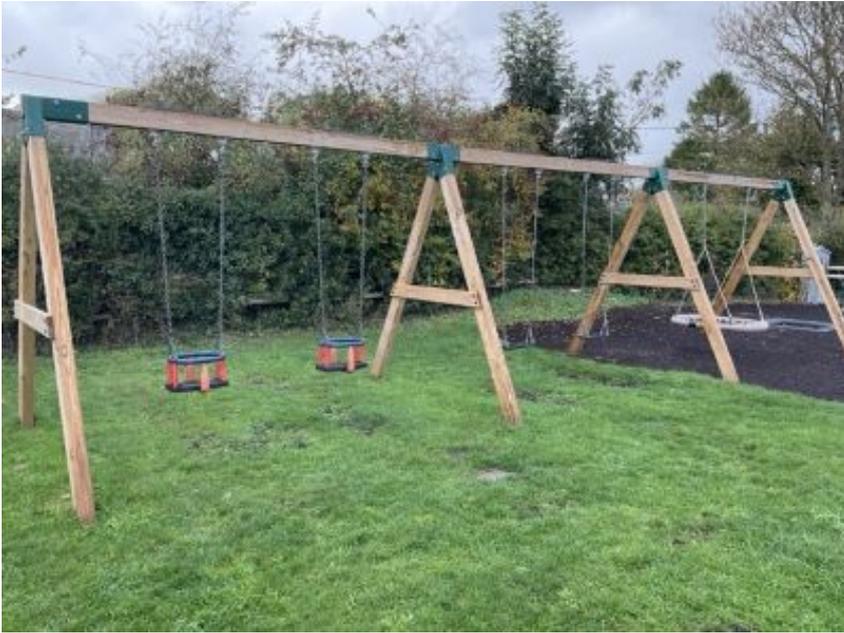
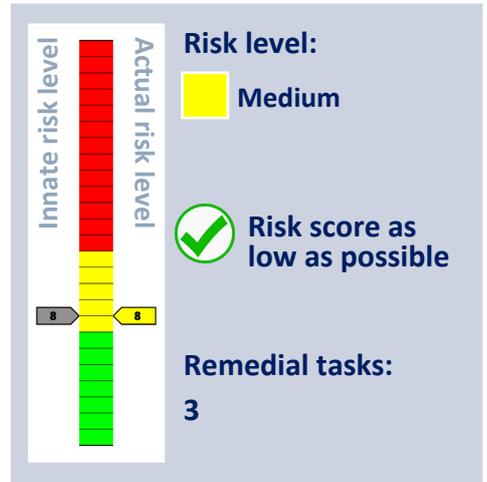
Swing - Mixed - 2 Bay 3 Seat

1. The swing seat has been damaged, but does not require immediate replacement.

Adjust to give a minimum of 350 mm clearance for standard seats, and 400 mm for tyres, baskets and other groups seats. We recommend a minimum of 500 mm seat height to reduce foot drag and surface wear.

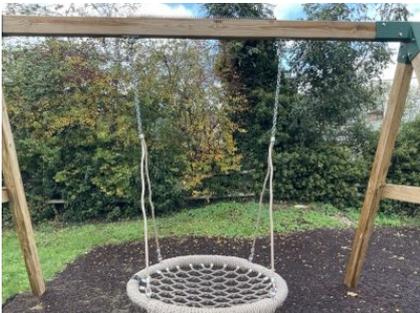
The swing seat has been damaged, but does not require immediate replacement.

Replace. Refer to manufacturer for comment.
